**MANDATORY**  
**SERVICE BULLETIN**

**No. 0002**

**SUBJECT:** Replacement of Duplicating Link @ STN 4

**MODELS AFFECTED:** Serial Numbers Affected:  
SE5A WA18  
WA19  
WA20

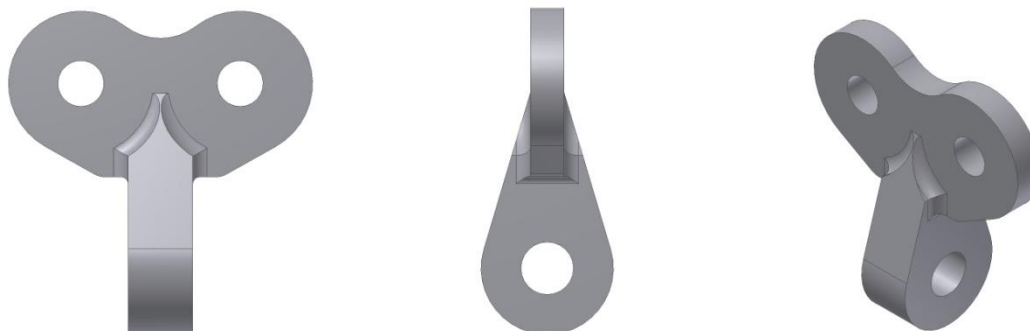
Part No. W1S010073

**PURPOSE:** Duplicating link W1S010073 transfers flight loads from the upper wing via a bracket at the junction of the strut and main spar. Two streamlined flying wires carry the load to an attachment bracket at the junction of the lower wing main spar and the fuselage. To increase the safety factor in the event that one of the streamlined flying wires fails, the fitting has been redesigned and manufactured from equivalent steel to RAF spec 6A.

**COMPLIANCE:** Replacement of duplicating link W1S010073 with duplicating link **W1S070030** by using the instructions described below will ensure full compliance with this service bulletin.

1. Order and install Duplicating Link @ STN 4 P/N W1S070030 to replace existing Duplicating Link P/N W1S010073.
