MANDATORY
SERVICE BULLETIN

No. 0004

SUBJECT: Aileron carry through cable pulley bracket.

MODELS AFFECTED: Serial Numbers Affected:
RE8 All
BE2F All
BE2E All

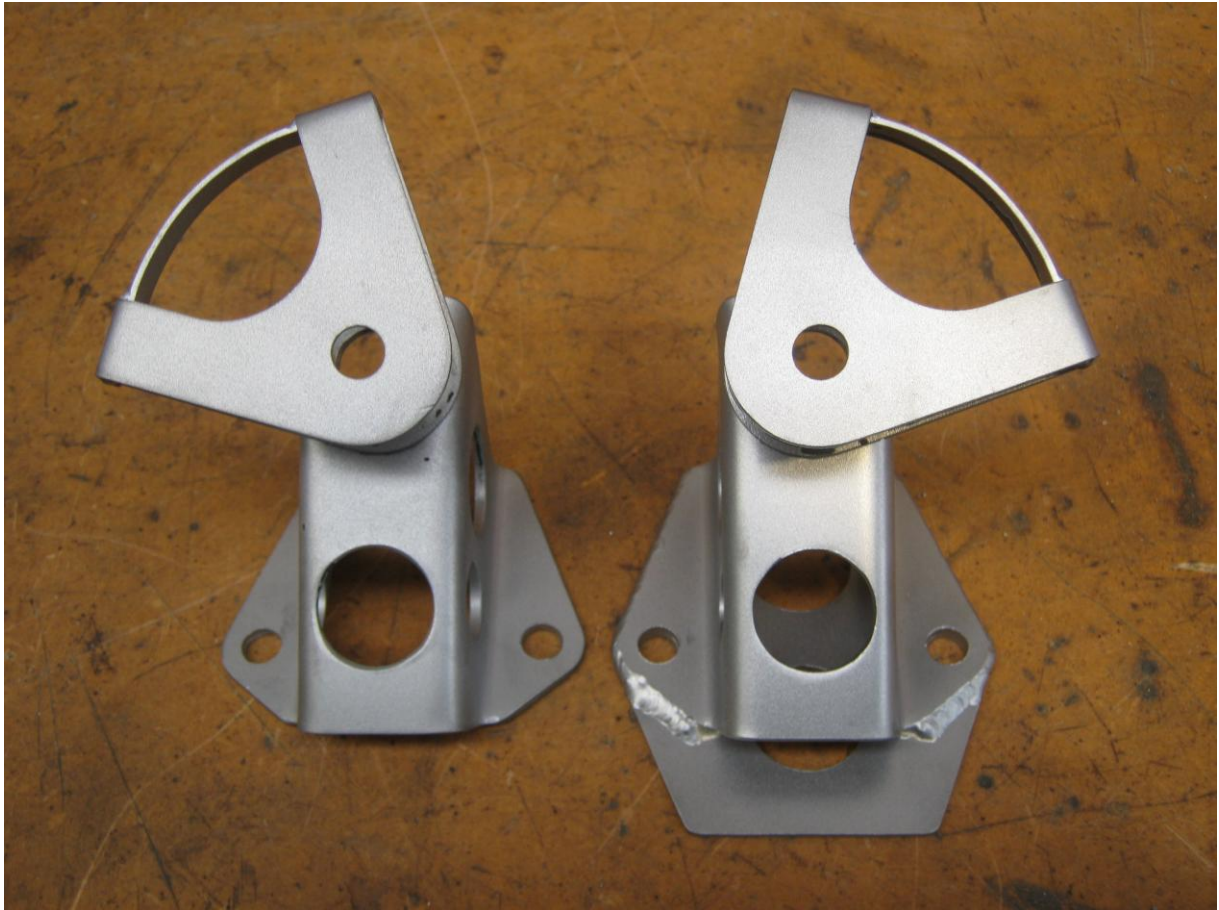
BACKGROUND: The Vintage Aviator has found that the Aileron carry through pulley brackets were changed from the original design to aid manufacture.

PURPOSE: This bulletin details a modification to the altered part increasing the surface area of the bracket that contacts the spar.

Photo of unmodified bracket on left, and modified bracket on right.

1. Identify the aileron carry through cable pulley brackets in both upper wings, and remove.
2. Modify affected brackets in accordance with The Vintage Aviator drawing No W1A070023 Rev -0.1. Welding must be accomplished using the TIG process and ER70-S as the filler material.
3. Paint and refit brackets to upper wings. Check control rigging and carry out duplicate inspections.
4. Make a logbook entry indicating compliance with this Service Bulletin.
