MANDATORY
SERVICE BULLETIN

No. 0005

SUBJECT: Replacement of Hori Stab trim adjuster bracing tube, upper bolt

MODELS AFFECTED: The Vintage Aviator Limited Royal Aircraft Factory R.E.8
Serial Numbers Affected:
0002 ZK-TVC

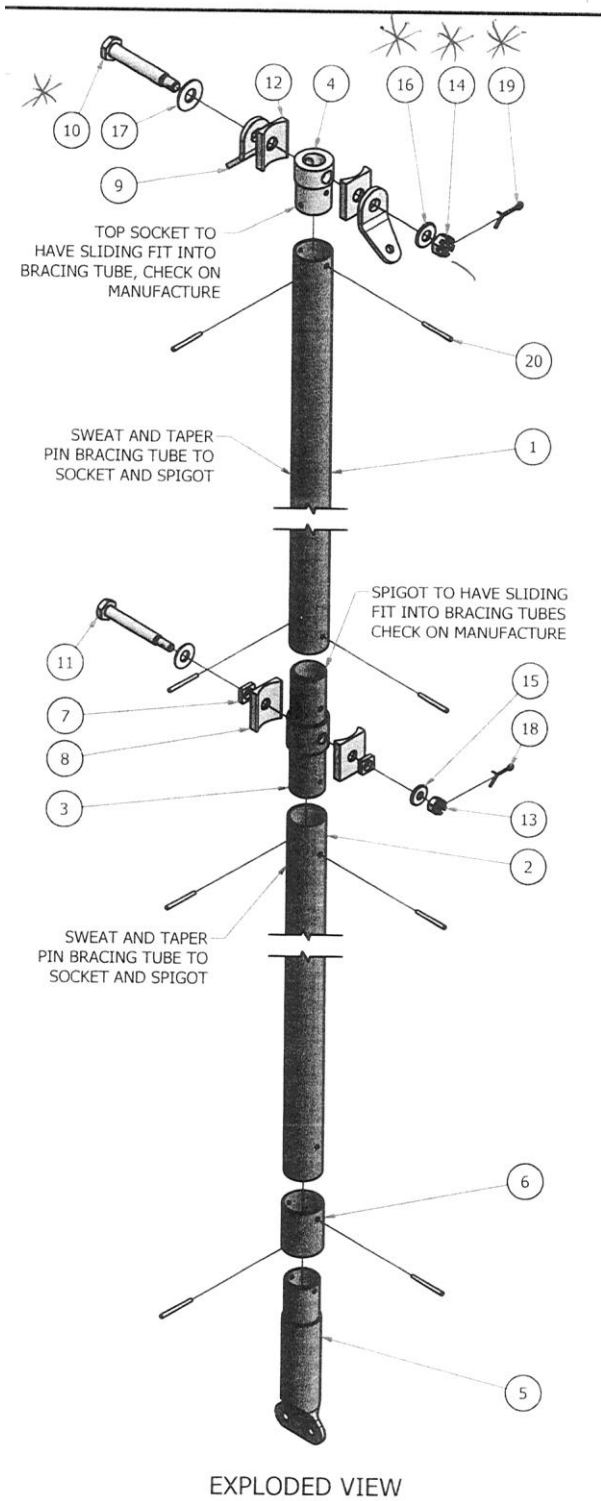
Figure 1

BACKGROUND: The Hori Stab trim adjuster bracing tube, upper bolt was designed using the trim adjuster shoulder bolt as a basis. Subsequent discovery of a later drawing for The RE8 Maori aircraft revealed that the design & materials of the upper bolt was incorrect and weaker than the original attachment bolt.

1. Remove the existing Shoulder bolt W1R030810 (10), Washer W4A0300-0400 (16), Nut W4A0202-800 (14) & Split Pin W4A1800-0400 (19) from the Bracing Tube Assembly for Trim Adjustor TVA P/N W1R030800
2. Install a new 5/16" AGS Bolt W4A0100-1016H / 2A15Y-16E (10), Washer W4A0300-0500 (16), Nut W4A0202-1000 / AGS 118C (14), & Split Pin AGS 166 3/32 x 1" (19)
3. Adjust the tension on the wires in accordance with the Aircraft maintenance manual
4. Make a logbook entry indicating compliance with this Service Bulletin
