MANDATORY
SERVICE BULLETIN

No. 0011

SUBJECT: TVAL RAF1a engine propeller shaft cracking.

MODELS AFFECTED: All TVAL built RAF1a engines.

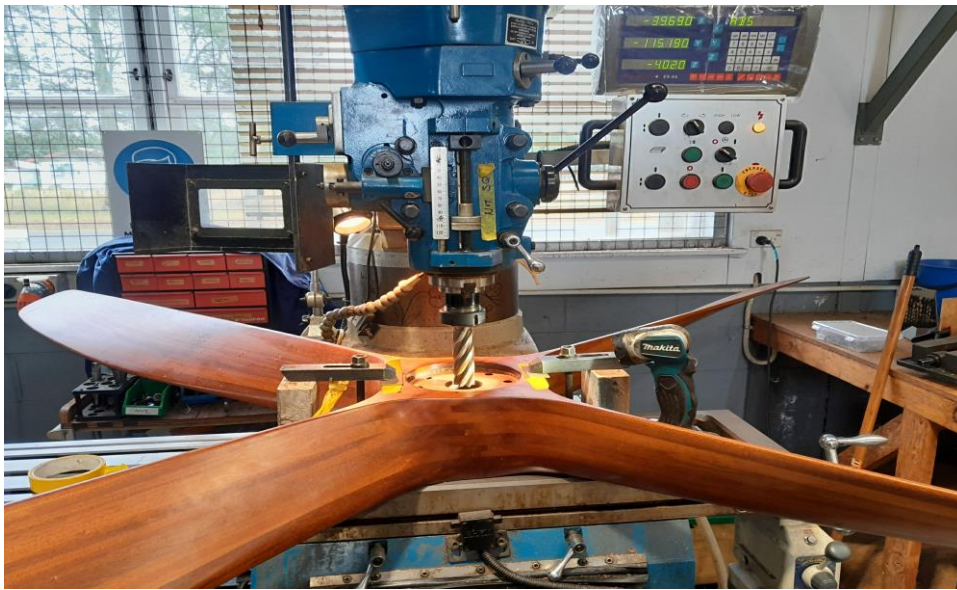
Photo 1. An example of one method to machine material out of the back side of the propeller.

3. Mark the position of the propeller drive hub relative to the backing plate and propeller, then remove the bolts and hub.
4. Measure the thickness of the propeller where the hub sandwiches it together. If the measurement is more than 100.7mm, carefully machine some wood from the rear face until the thickness reaches 100.7mm. Note. It will be necessary to reinstate the radius in the propeller hub bore so that the rear plate sits flat against the newly machined face.

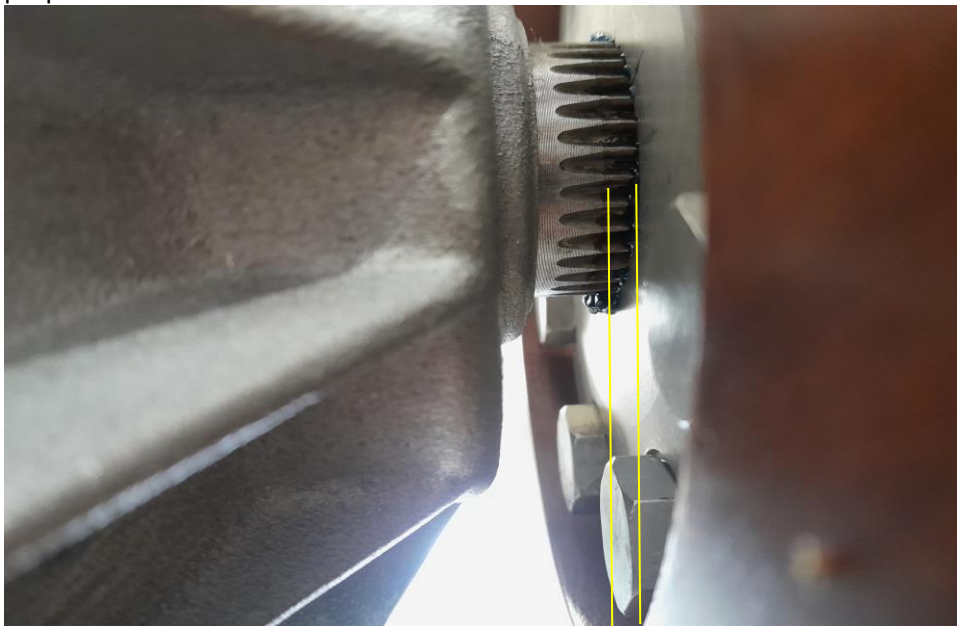
Photo 2. Measurement points between the yellow lines. Must be 2mm or greater.

1. Inspect the propeller hub fitment to determine if it is hard up against the lead-out of the propeller shaft splines, or if at least 2mm clearance exists as per Photo 2. If 2mm, or more clearance is found, then this inspection is complete. Make an entry in the maintenance logbooks that this Service Bulletin has been complied with. If less than 2mm clearance exists, go to instruction number 2.
