MANDATORY
SERVICE BULLETIN

No. 0001

SUBJECT: Failure of front landing wires.

MODELS AFFECTED: Serial Numbers Affected:
SE5A WA18
WA19
WA20

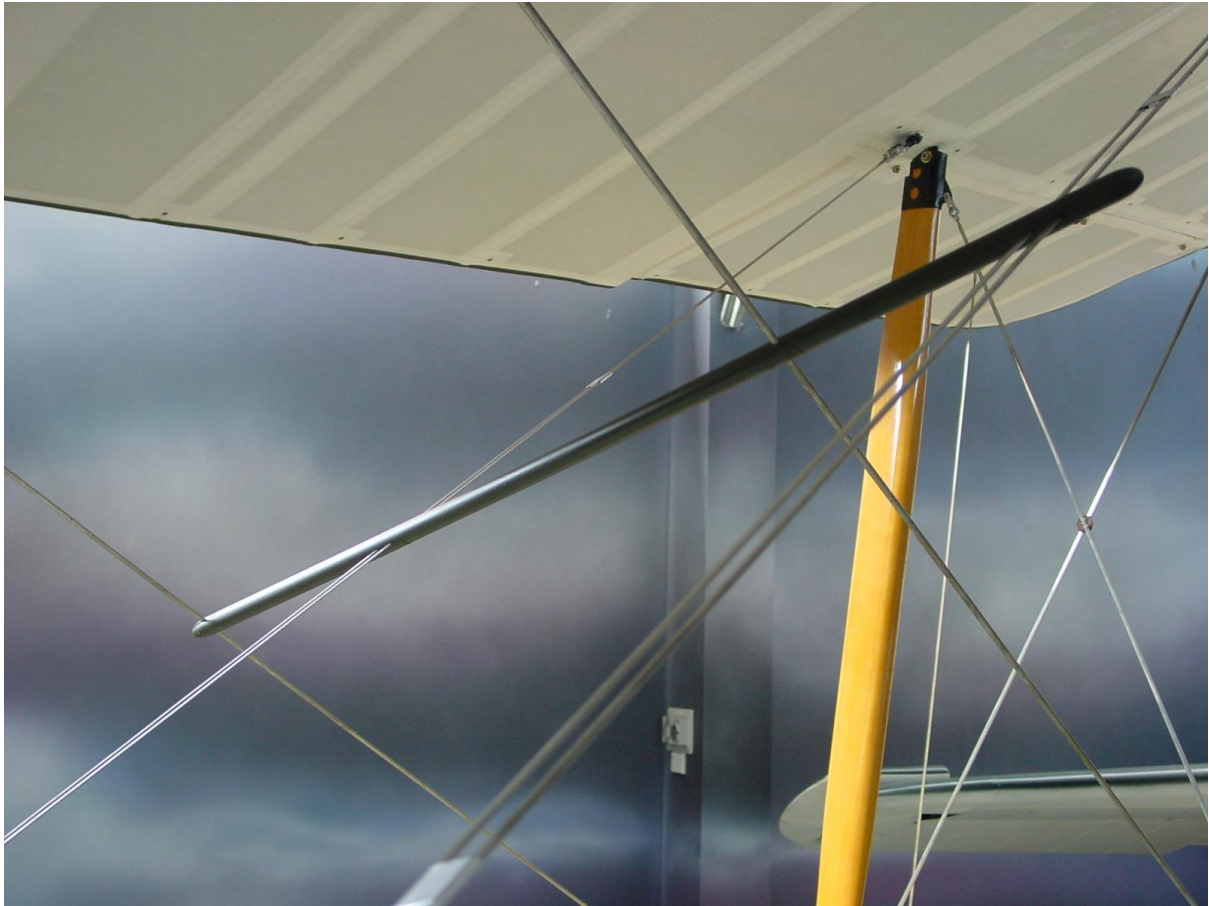
BACKGROUND: The Vintage Aviator has had two reported cases of the front landing wire p/n W4E00321-94.5 failing in flight. In both cases the pilot has been able to return to the Aerodrome and land without incident.

PURPOSE: The landing wires take the weight of the wings when the Aircraft is on the ground, or landing. When the aircraft is Flying these wires have less tension due to the flight loads and may vibrate in the airflow causing cyclic failure.

Photo of completed port wing installation.

1. Make javelins out of ¾" wooden dowel rod to hold all landing, and flying wires at their point of intersection. Fit to both wing bracing wires (see photo).
2. Inspect landing wires visually at 10hr, or annual intervals whichever comes first.
3. Make a logbook entry indicating compliance with this Service Bulletin.
