RECOMMENDED **SERVICE BULLETIN**

No. 0009

SUBJECT: Seat Belt Cutters

MODELS AFFECTED: All aircraft produced by The Vintage Aviator Limited that are fitted with an authentic German style seat belt, or English Sutton Harness.

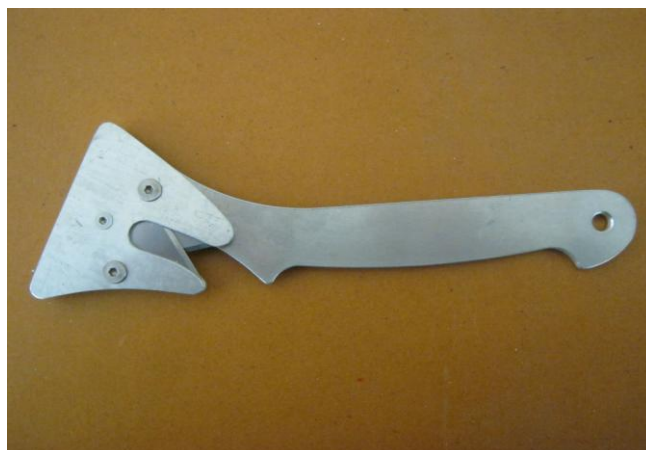
Example of Seat belt cutter made by The Vintage Aviator Ltd.

1. Determine a suitable location for the seat belt cutter that will not interfere with the operation of the aircraft, or any moving parts, including controls. Ideally this cutter should be placed in a loose fitting pouch or box that would restrain it, but allow it to freely fall out if the aircraft was inverted.
2. Tie the seat belt cutter into the aircraft in such a manner, that if the aircraft were to be inverted, the cutter would be hanging in an accessible position for the pilot to be readily able to use.
3. Make a logbook entry indicating compliance with this Service Bulletin.
